Anne Arundel County Special IDDE Site Visit Report

Location: The intersection of Deale Place and Park Place, Deale MD
Date: July 10, 2019
Investigators: M. Berlett and G. Rogers
Concern: Possible sewage source for bacteria in Rockhold Creek

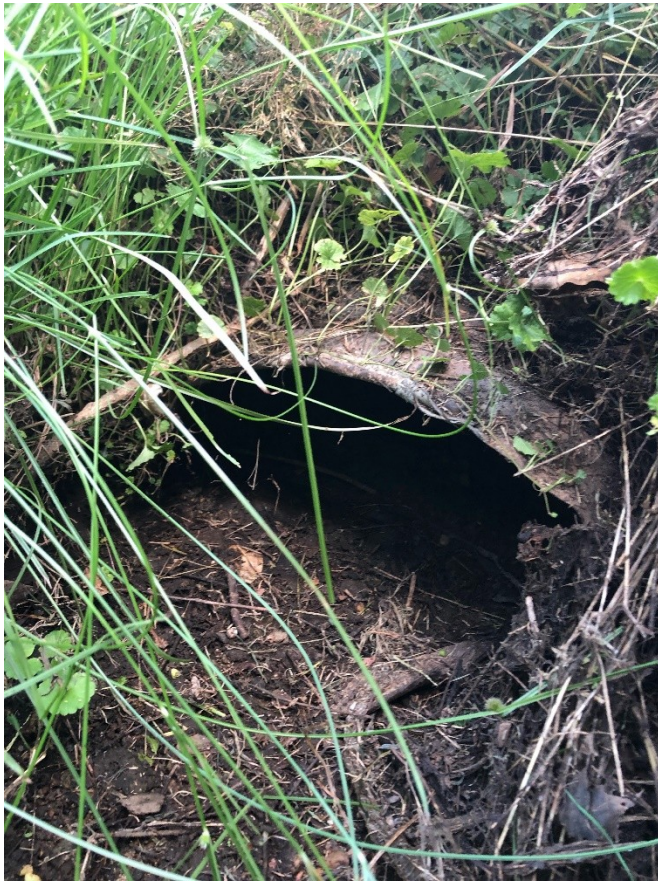
Figure 1. A view of the outfall Q34O002

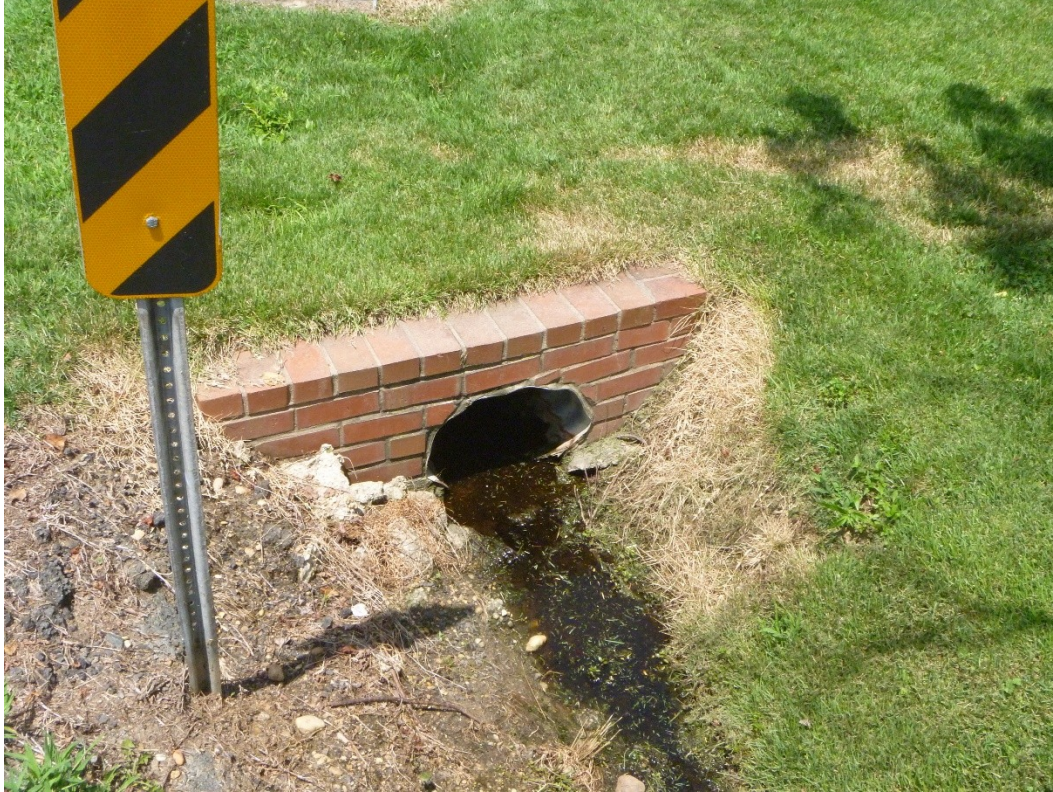
Referring to the field test results found in Table 1, the relatively high temperature of the sample likely reflected the exposure of the stagnant water to direct sunlight, and thus could not reliably be used as an indicator. The sample did not exhibit a detectable odor or color. The test results indicated measurable levels of the three analytes (chlorine, detergents, and ammonia), but none of the readings exceeded the program criteria that would indicate the potential for non-stormwater discharges. Thus, the field team did not document conclusive evidence to support an inference that the stormwater runoff through the network connected to outfall Q34O002 had been conveying sewage with its discharge.

Figure 2. A view of the standing water in the pipe of inlet Q34C8I00003

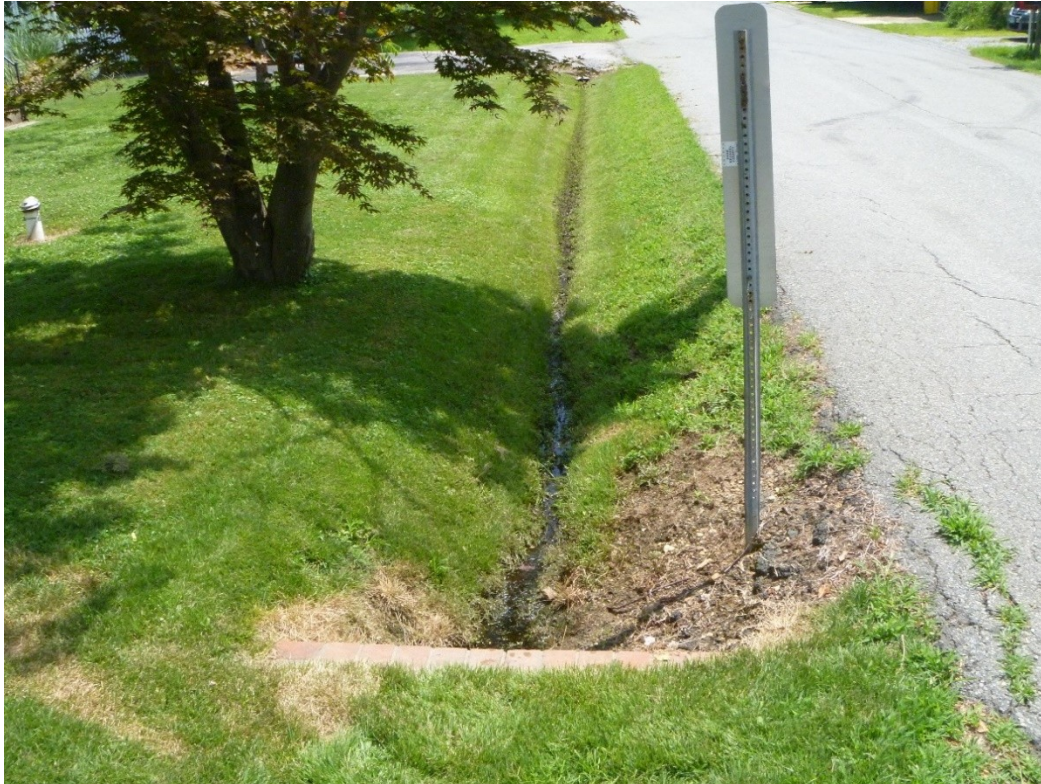
The team investigated the conditions in the vicinity of the outfall and along the drainage path from the outfall to the waterway, Rockhold Creek. The team did not observe signs of solid waste or damage to the sanitary sewer network near the outfall. The ditch that conveyed the outfall drainage toward the creek discharged to an open parcel directly behind the lot on the southeast

Figure 3. A view of the narrow ditch that drains toward inlet Q34C8I00003; the inlet headwall is seen in the foreground

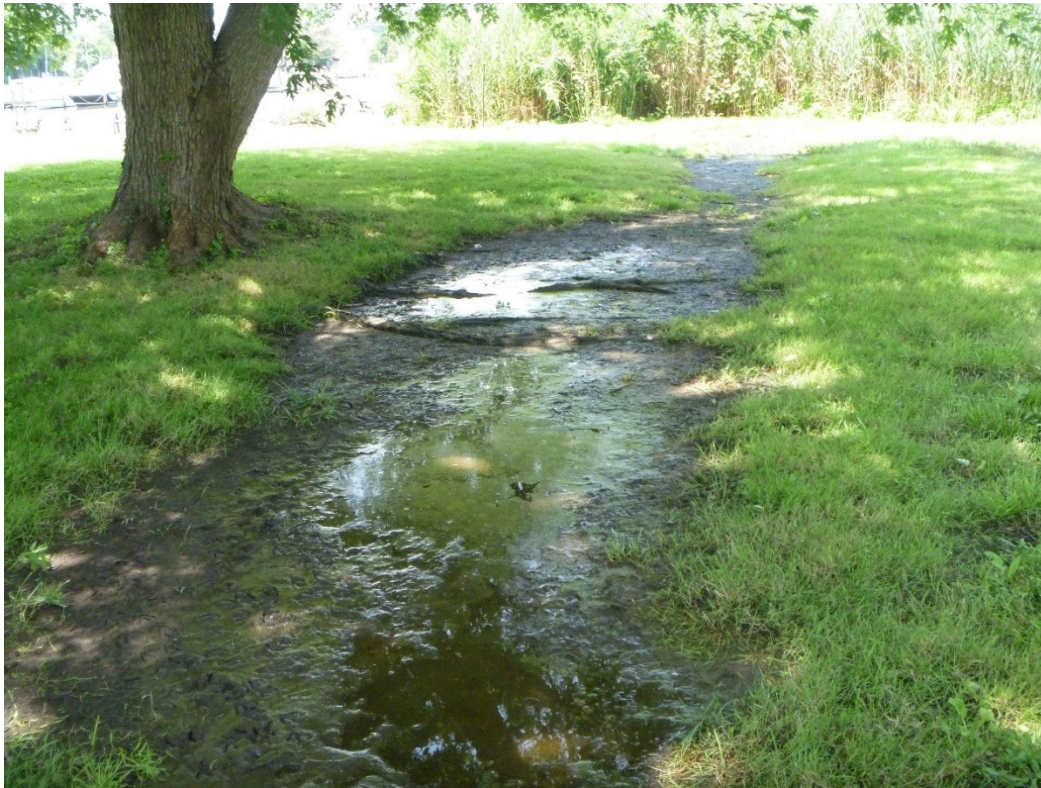
side of the intersection of Deale Place and Park Place. The team documented that the discharge extent broadens when it reaches a larger and flatter floodplain downstream of the south end of the ditch (Figure 4). It is here that the team documented the presence of approximately 45 geese and the tracks of many geese in the mud associated with the discharge path. The team surmised that if the geese frequent this area, goose droppings may be concentrated near the cove of the creek which abuts the western boundary of the open lot. If so, stormwater discharge may transport bulk material and leachate from the droppings into the cove at this location. The accumulated feces may be contributing to the growth in the populations of bacteria in the creek. An area map is provided in Figure 5.

Figure 4. A view of the flat plain that receives and distributes the discharge from the outfall see in Figure 1 and the drainage ditch seen in Figure 2; Rockhold Creek is visible in the background of the photograph
